HISTORIC AMERICAN BUILDINGS SURVEY
INVENTORY

2. NAME *Orrin Thompson Mansion*

DATE OR PERIOD *1832*
STYLE *Greek Revival*
ARCHITECT
BUILDER *Orrin Thompson*

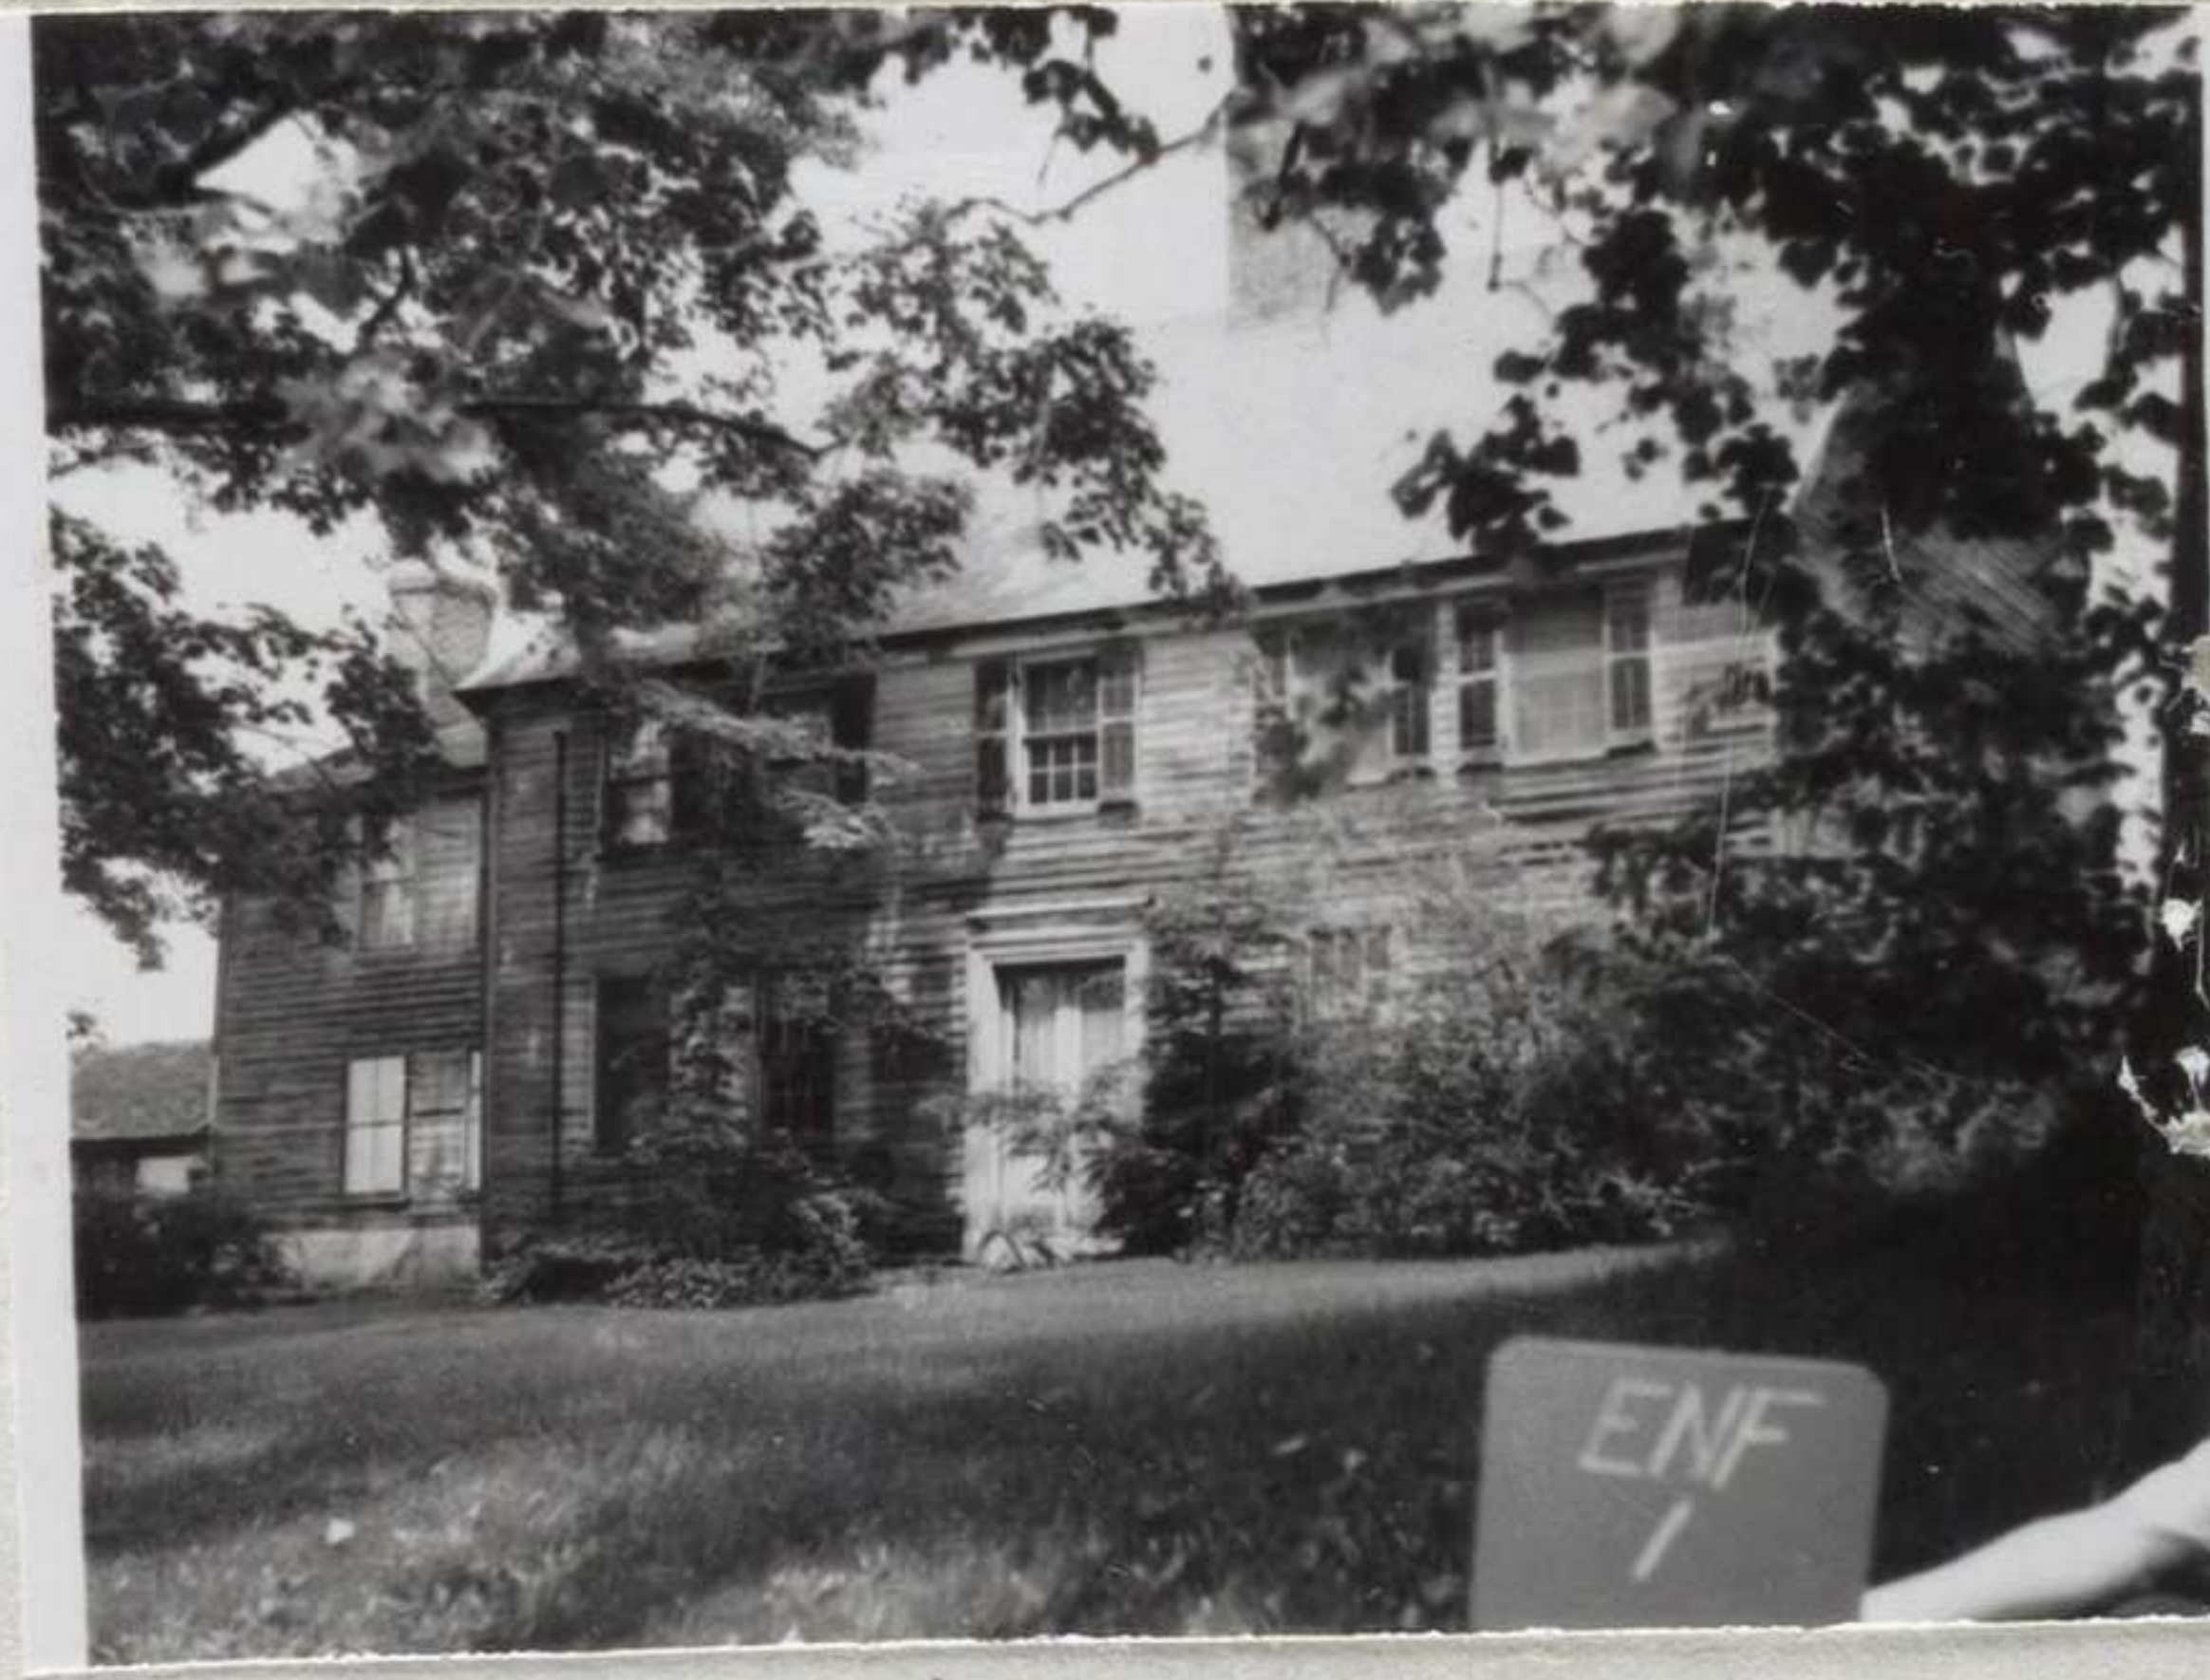
<p>7. PHOTOGRAPH <i>Enf 1</i></p>

<p>1. STATE <i>Ct</i> COUNTY <i>Hartford</i> TOWN <i>Enfield</i> VICINITY STREET NO. <i>1504 King Street</i></p> <p>ORIGINAL OWNER <i>Capt. Dennis Bement</i> ORIGINAL USE <i>Residence</i> PRESENT OWNER <i>Mr. Robert Welsh</i> PRESENT USE <i>Residence</i> WALL CONSTRUCTION <i>clapboard</i> NO. OF STORIES <i>2</i></p>	<p>HISTORIC AMERICAN BUILDINGS SURVEY INVENTORY</p> <p>2. NAME <i>Capt. Dennis Bement</i></p> <p>DATE OR PERIOD <i>1711</i> STYLE <i>Georgian Colonial</i> ARCHITECT BUILDER <i>Capt. Dennis Bement</i></p> <p>3. FOR LIBRARY OF CONGRESS USE</p>
<p>4. NOTABLE FEATURES, HISTORICAL SIGNIFICANCE AND DESCRIPTION</p> <p style="text-align: right;">OPEN TO PUBLIC <i>No</i></p> <p><i>The land on which this house is built was deeded to the Bements in 1698. Although in a state of deterioration, the house retains most of its early fabric. Unfortunately according to friends of Mr. Welsh, he is considering the destruction of this fine house. Built on a brownstone foundation this house has that solid and strong look of early Ct houses, particularly due to its very high peaked roof and huge gable. There are five bays with 6/6 windows which no doubt replaced 12/12 in the late 18th century. The double doors are nineteenth century but the doorway has probably always been double. The molding is simple but fine. There is also a coffin door to the left. The chimney is original being large and central. A wing of the late 18th century extends to the West.</i></p> <p>5. PHYSICAL CONDITION OF STRUCTURE Endangered <i>Yes</i> Interior <i>fair</i> Exterior <i>poor</i></p>

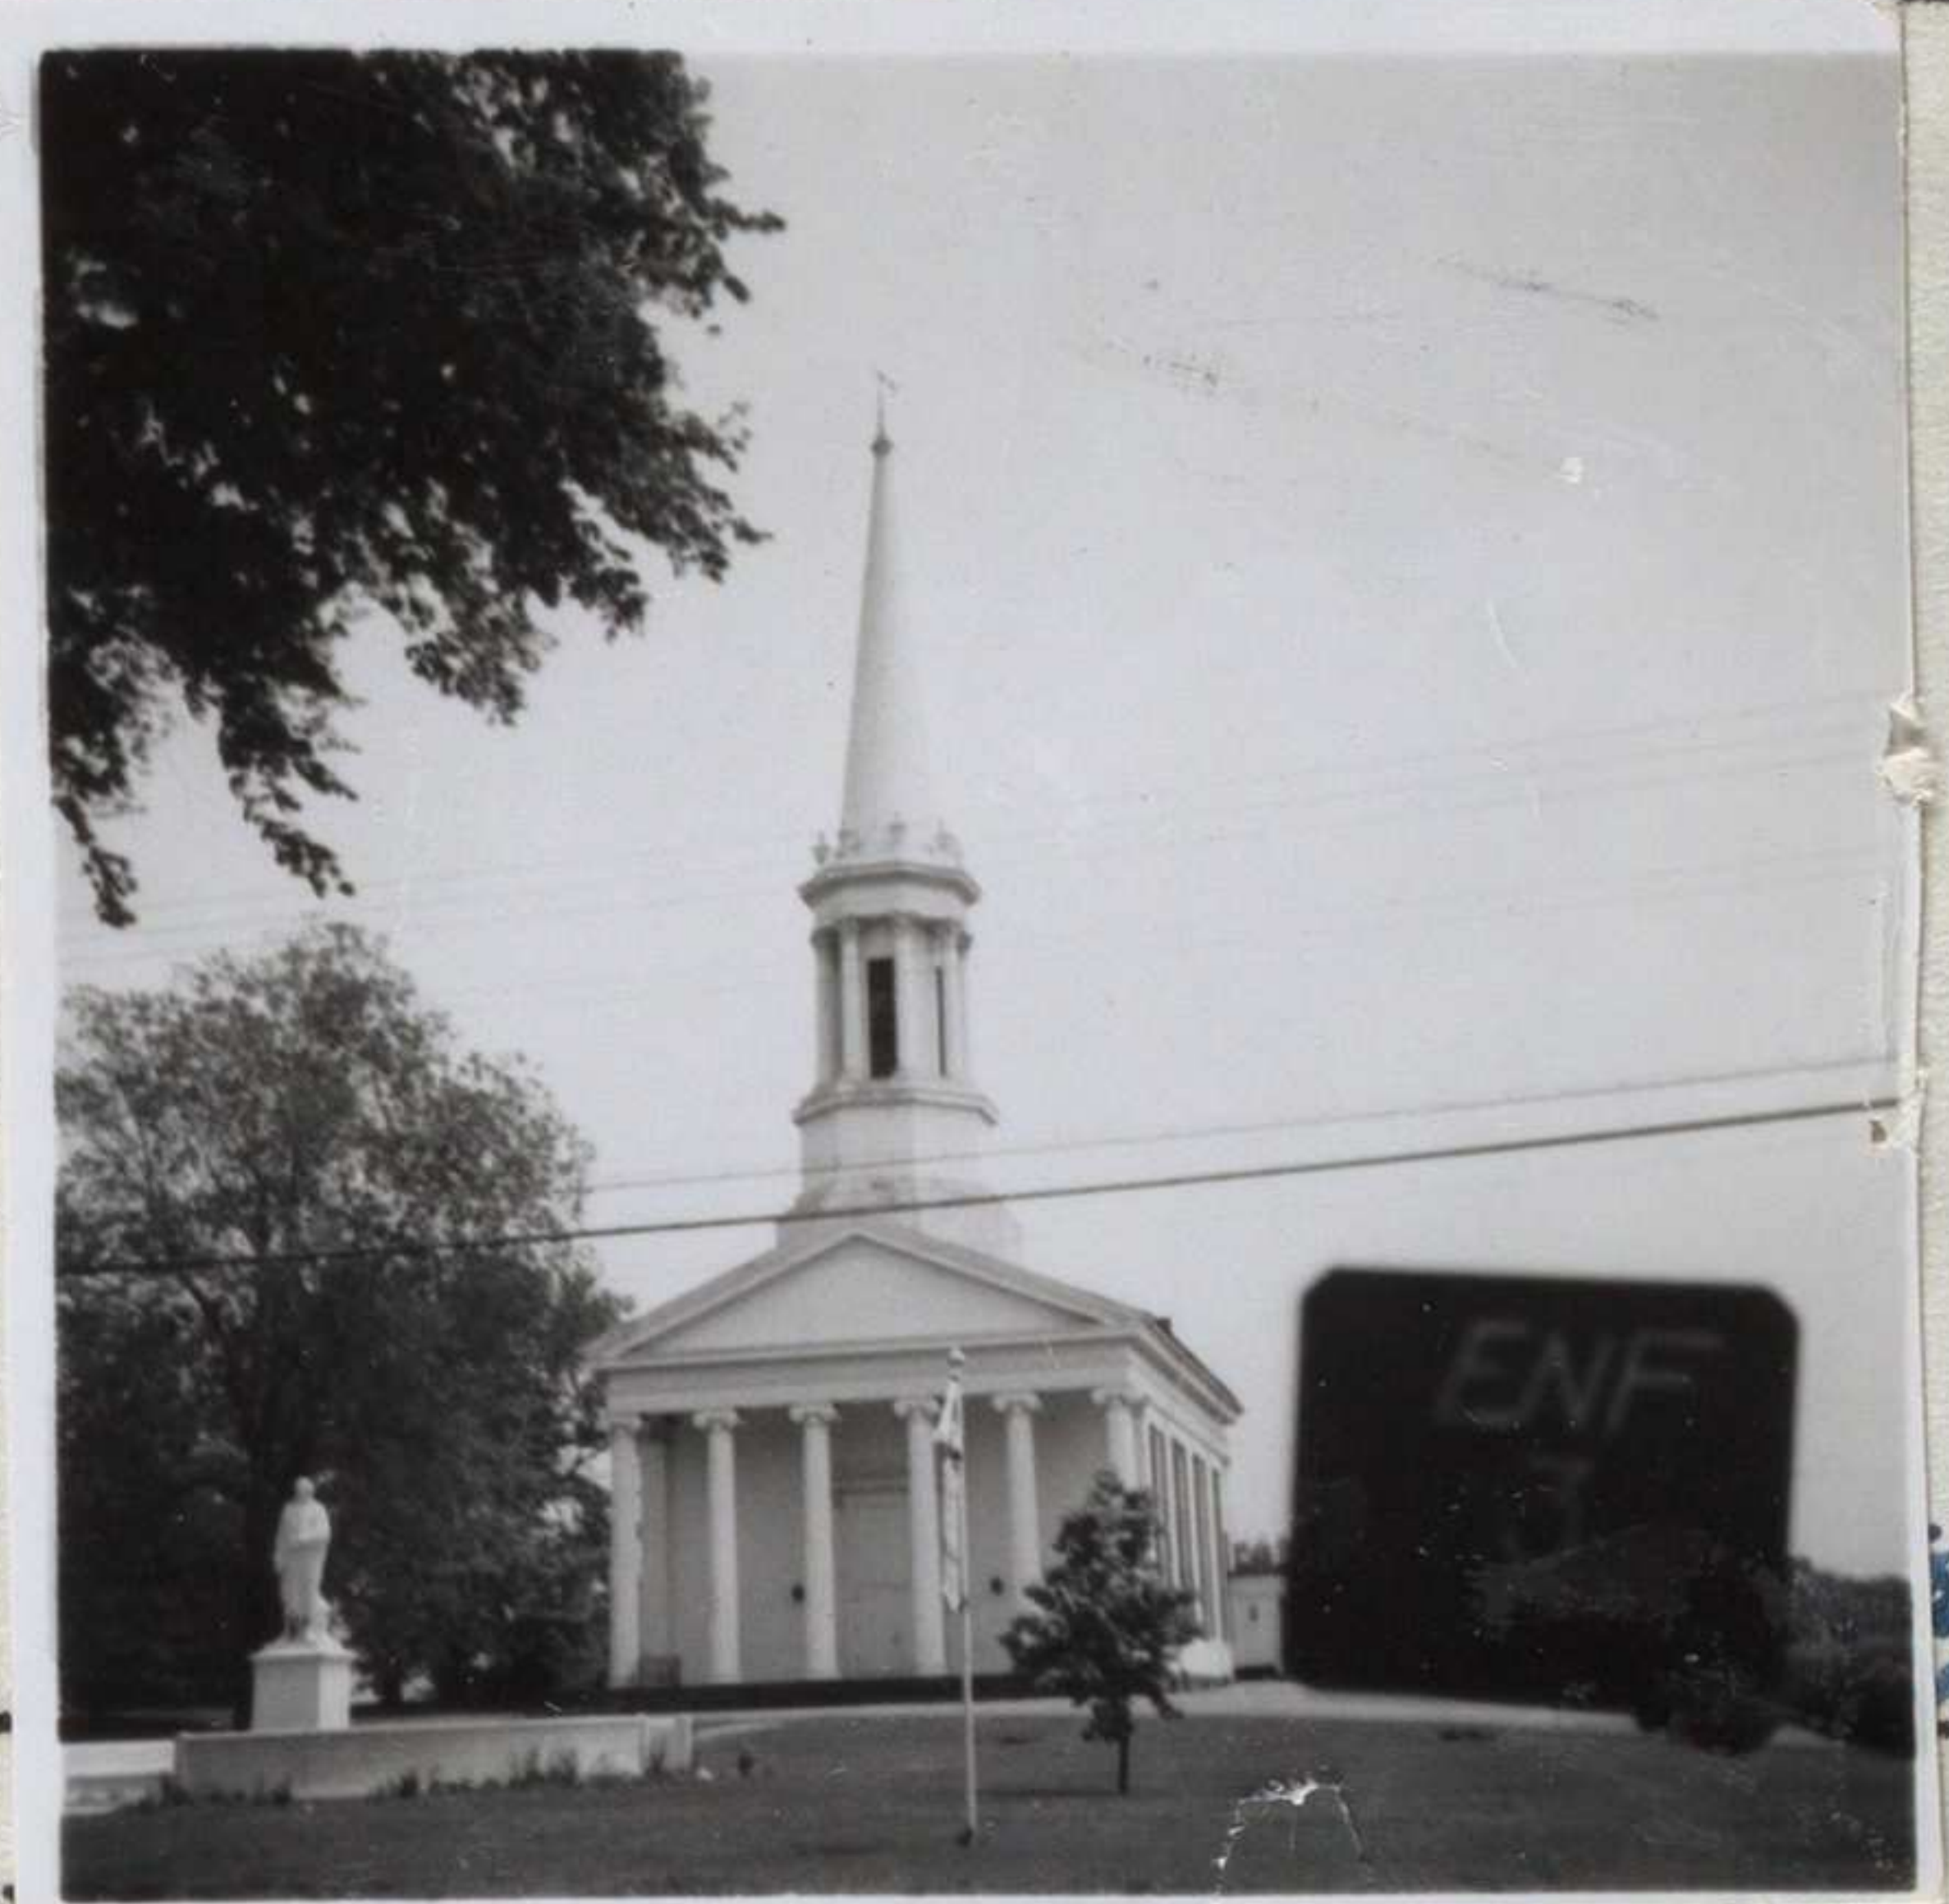
<p>1. STATE <i>CT</i> COUNTY <i>Hartford</i> TOWN <i>Enfield</i> VICINITY STREET NO. <i>NE corner of Enfield and South Streets</i> ORIGINAL OWNER <i>Congregational Church</i> ORIGINAL USE <i>Church</i> PRESENT OWNER <i>Congregational Church</i> PRESENT USE <i>Church</i> WALL CONSTRUCTION <i>Clapboard and Board</i> NO. OF STORIES <i>2</i></p>	<p>HISTORIC AMERICAN BUILDINGS SURVEY INVENTORY</p> <p>2. NAME <i>Fourth Church</i> DATE OR PERIOD <i>1849</i> STYLE <i>Greek Revival</i> ARCHITECT BUILDER <i>Orin Thompson, et al</i></p> <p>3. FOR LIBRARY OF CONGRESS USE</p>
<p>4. NOTABLE FEATURES, HISTORICAL SIGNIFICANCE AND DESCRIPTION</p> <p style="text-align: right;">OPEN TO PUBLIC <i>Yes.</i></p> <p><i>Through the strong influence of Orrin Thompson, Enfield's magnificent 19th century millionaire a move was made in the late 1840's to raise this mighty new edifice replacing the Third Meetinghouse now called "Old Town Hall." Architects who consider this fine building "the finest example of Colonial Architecture in New England" can not be very good architects, not because it is anything but a fine example but because colony days were long since over and the new American forms borrowed from classic antiquity were in full force. Nevertheless, it is perhaps strange to find a spire on a church of the period. Most Greek Revival towers were one or more square temple forms with the palest of pitches to the topmost section. The Fourth church instead has a conical spire built on an</i></p> <p>5. PHYSICAL CONDITION OF STRUCTURE Endangered <i>No</i> Interior <i>good</i> Exterior <i>good</i></p>

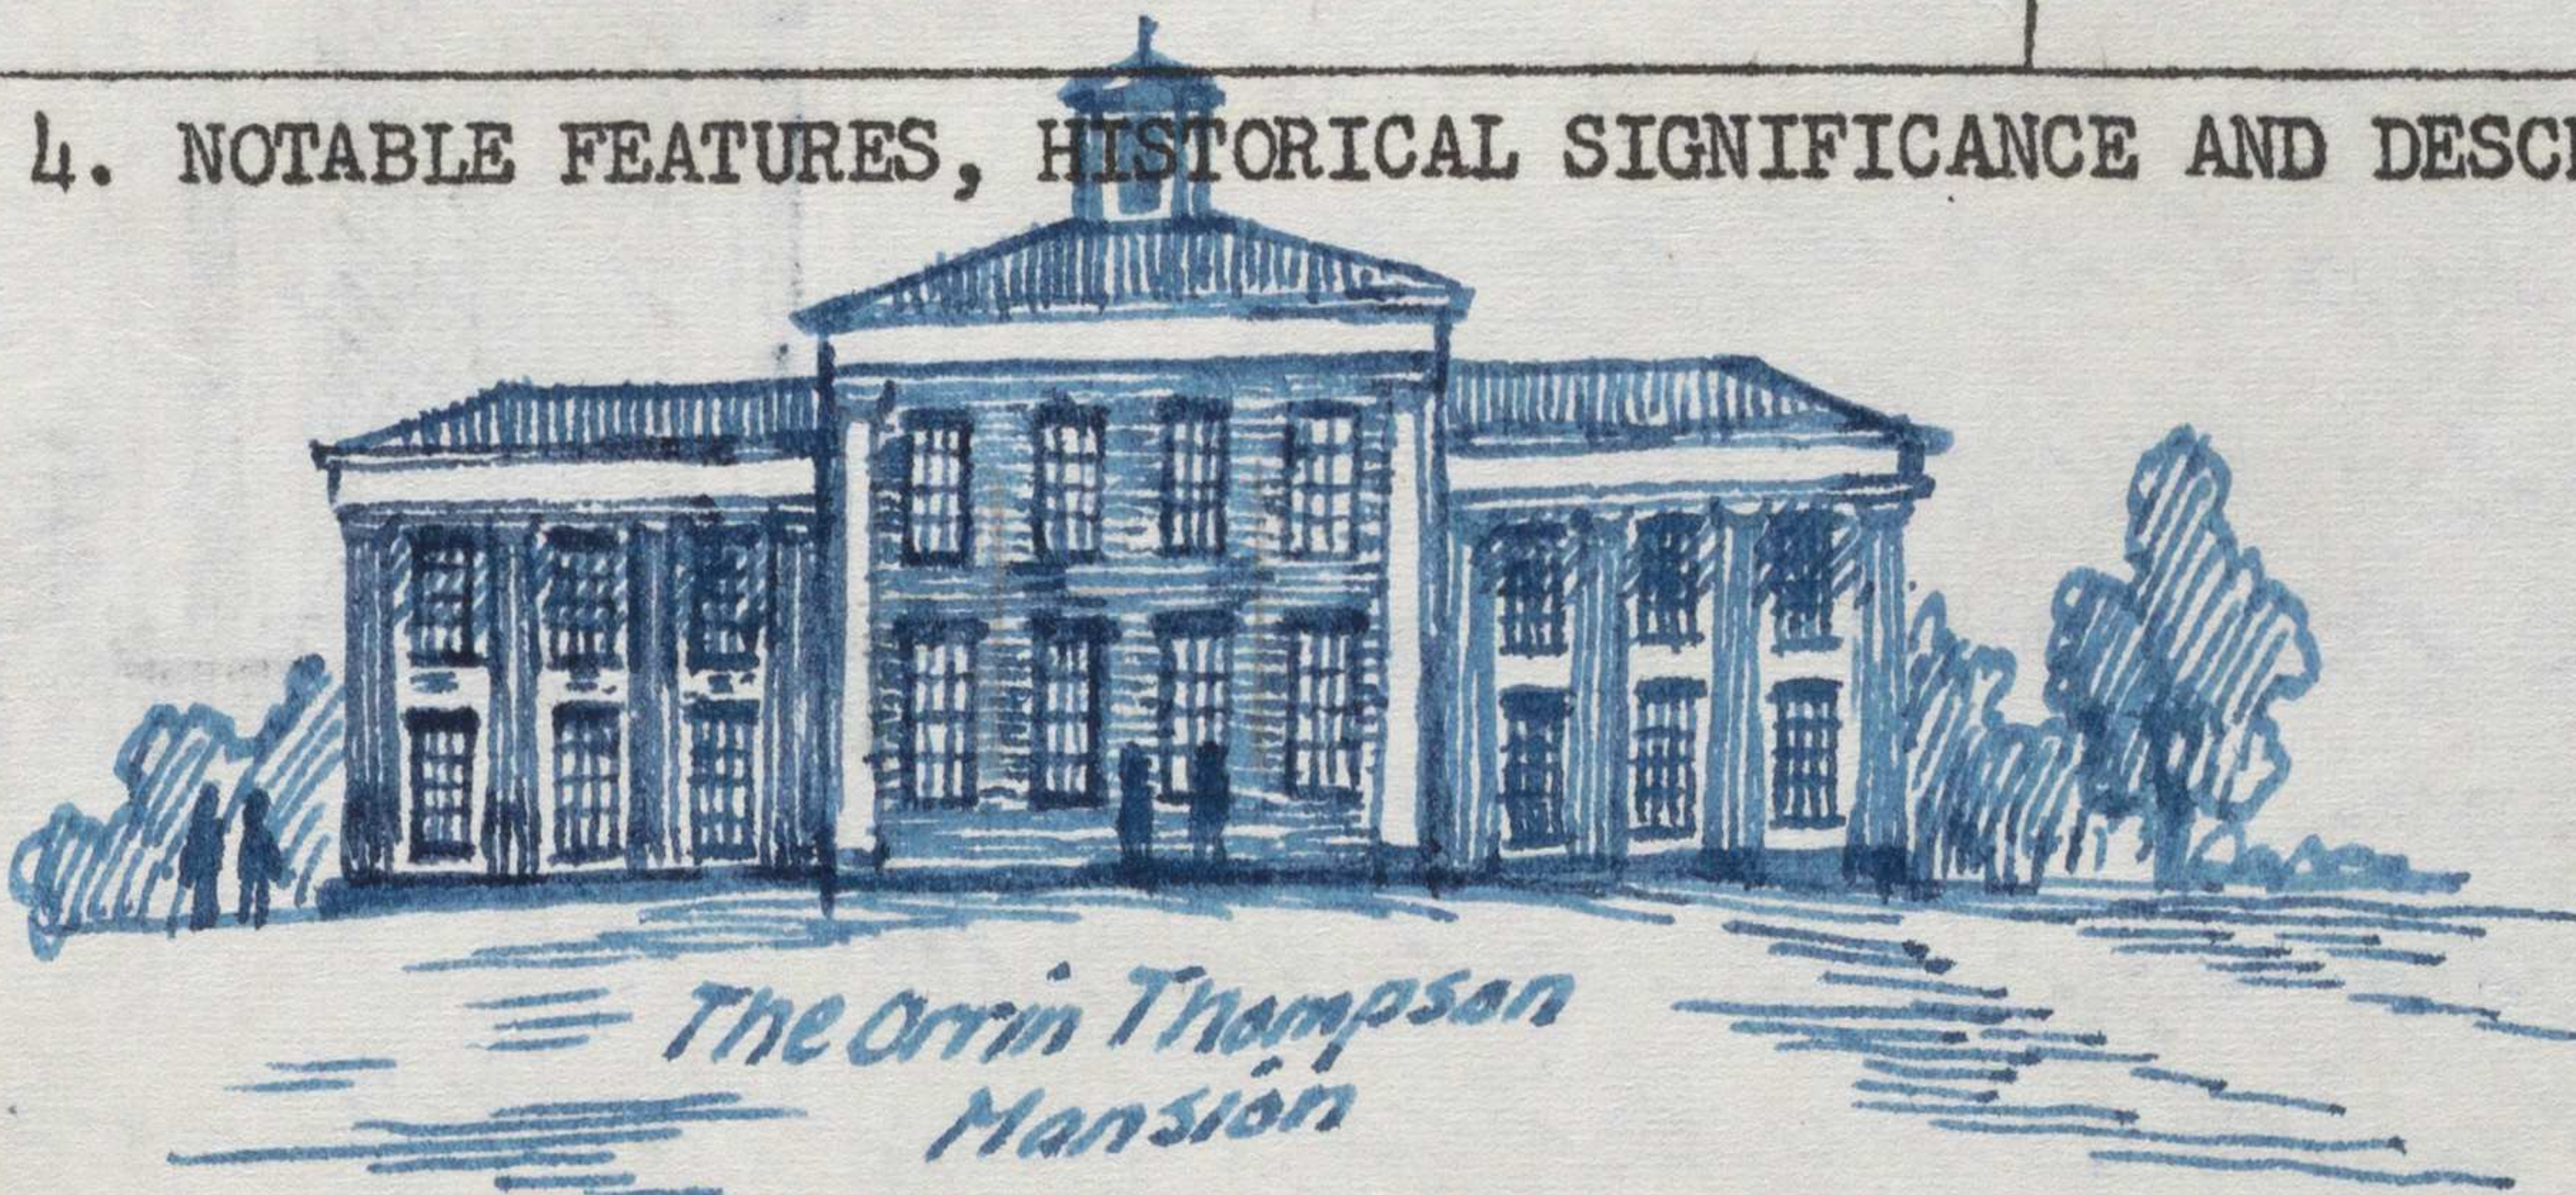
The magnificent Orrin Thompson Mansion has proportions so incredibly huge that it resembles a state capital more than a private home. It has so many notable ^{features} that no matter how many I may mention here the house itself must be its own best descriptive force. Basically it is arranged on its facade in three pavilions. The center, monitor roofed section is like entire building of brick. It has four facade bays. The entrances to the house are identical doorways at the sides off the ^{over}

Endangered *No* Interior *fair?* Exterior *good.*
